Remedial Actions at Hazardous Waste Sites
Survey and Case Studies

SCS Engineers
Covington, KY

Municipal Environmental Research Lab.
Cincinnati, OH

Jan 81

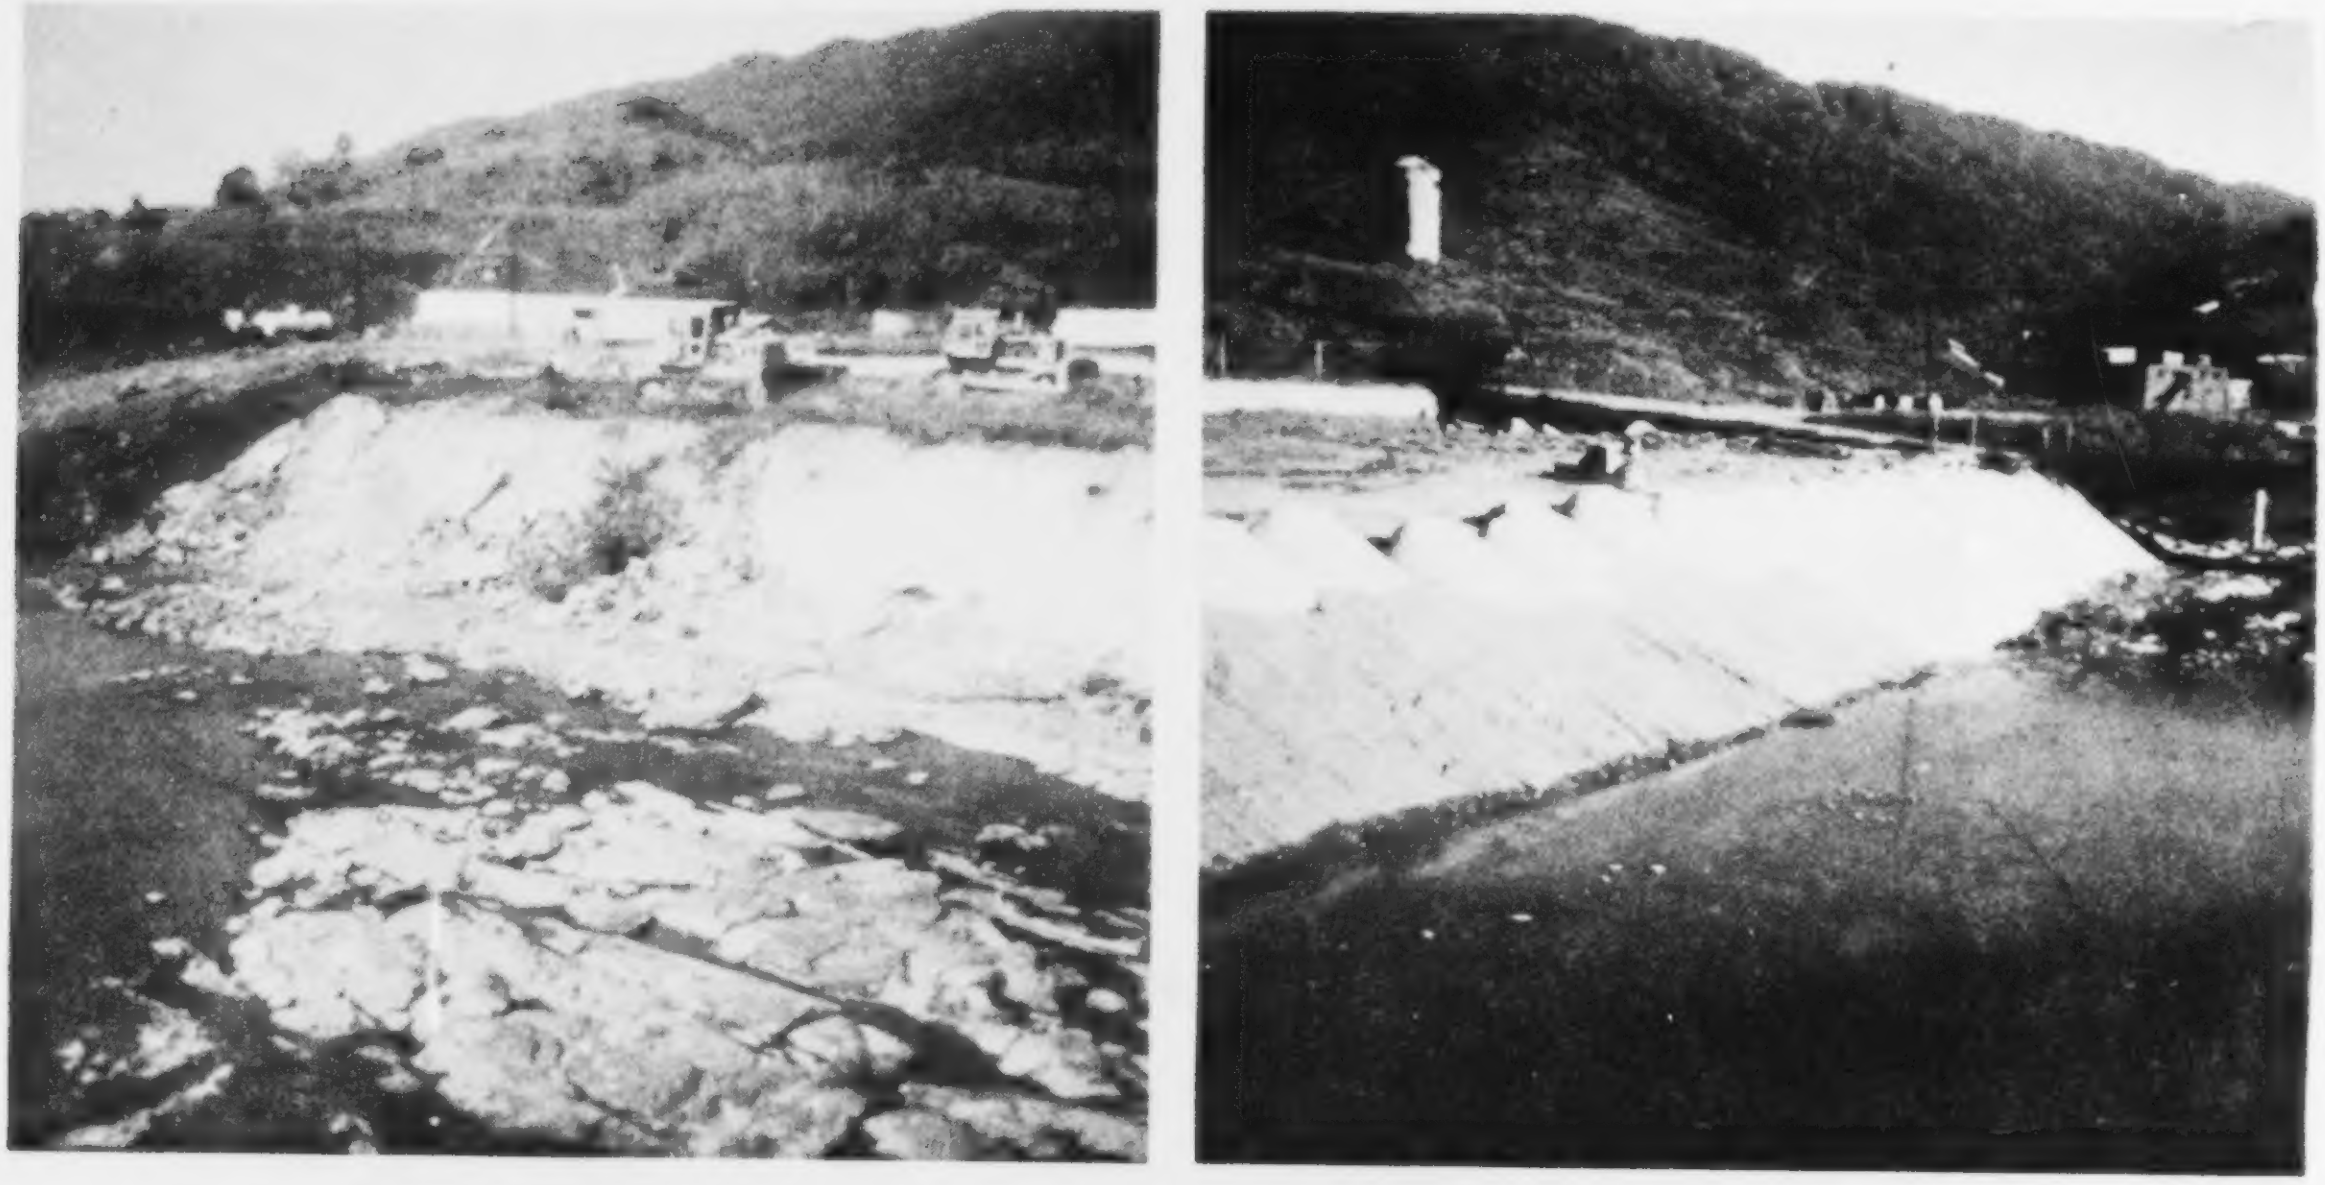
Appearance of river bank bordering chlorine plant site before and after sloping and sand application.

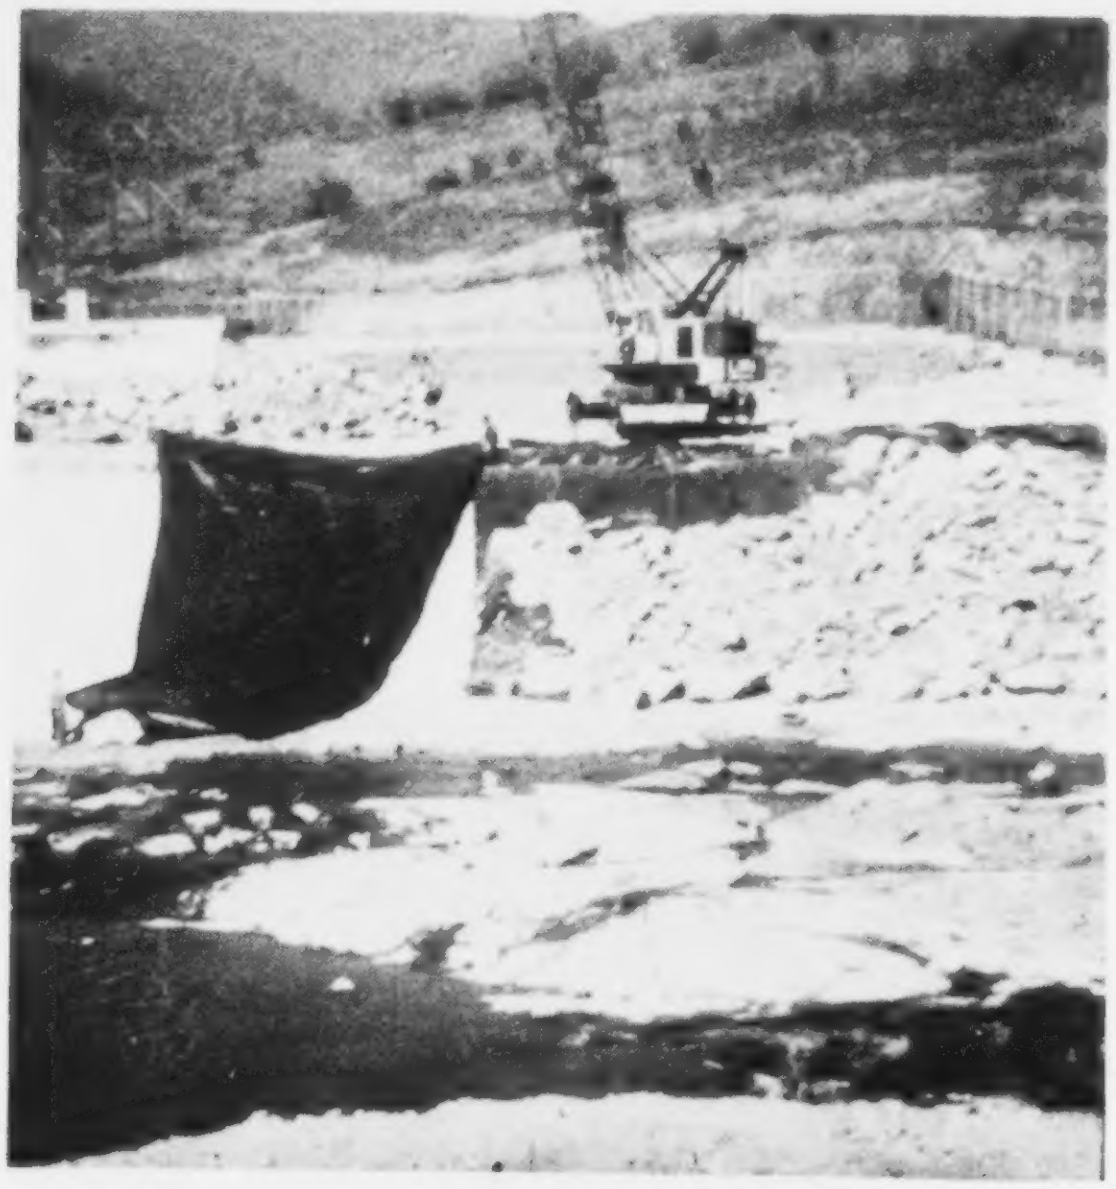
Application of plastic liner and riprap to resloped, sanded embankment of chlorine plant site.

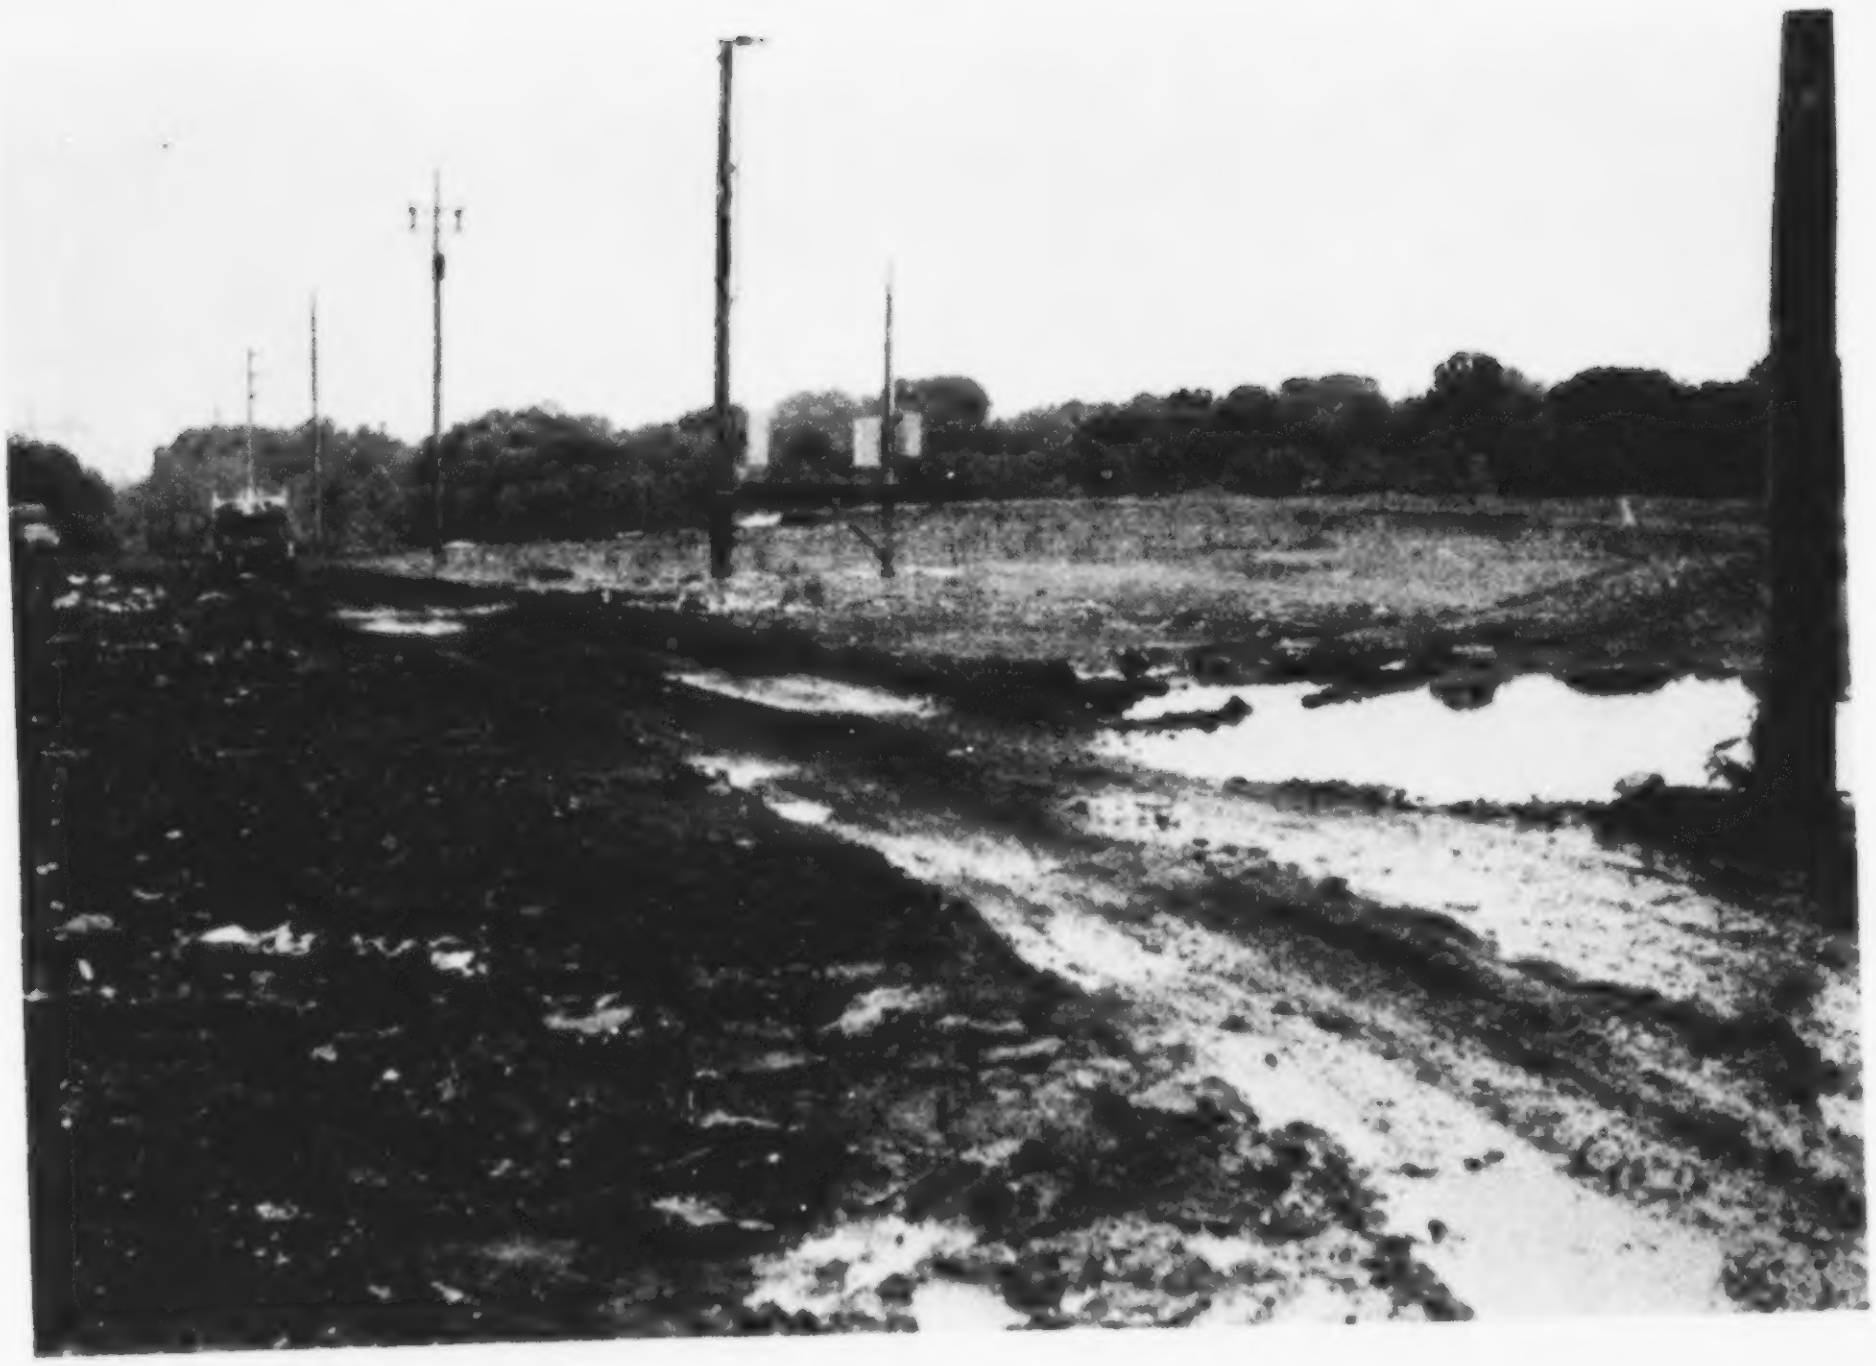
View of part of the old landfill. Note access road and trees (which border the river) in the background. Ponded water is the result of a recent rainfall.

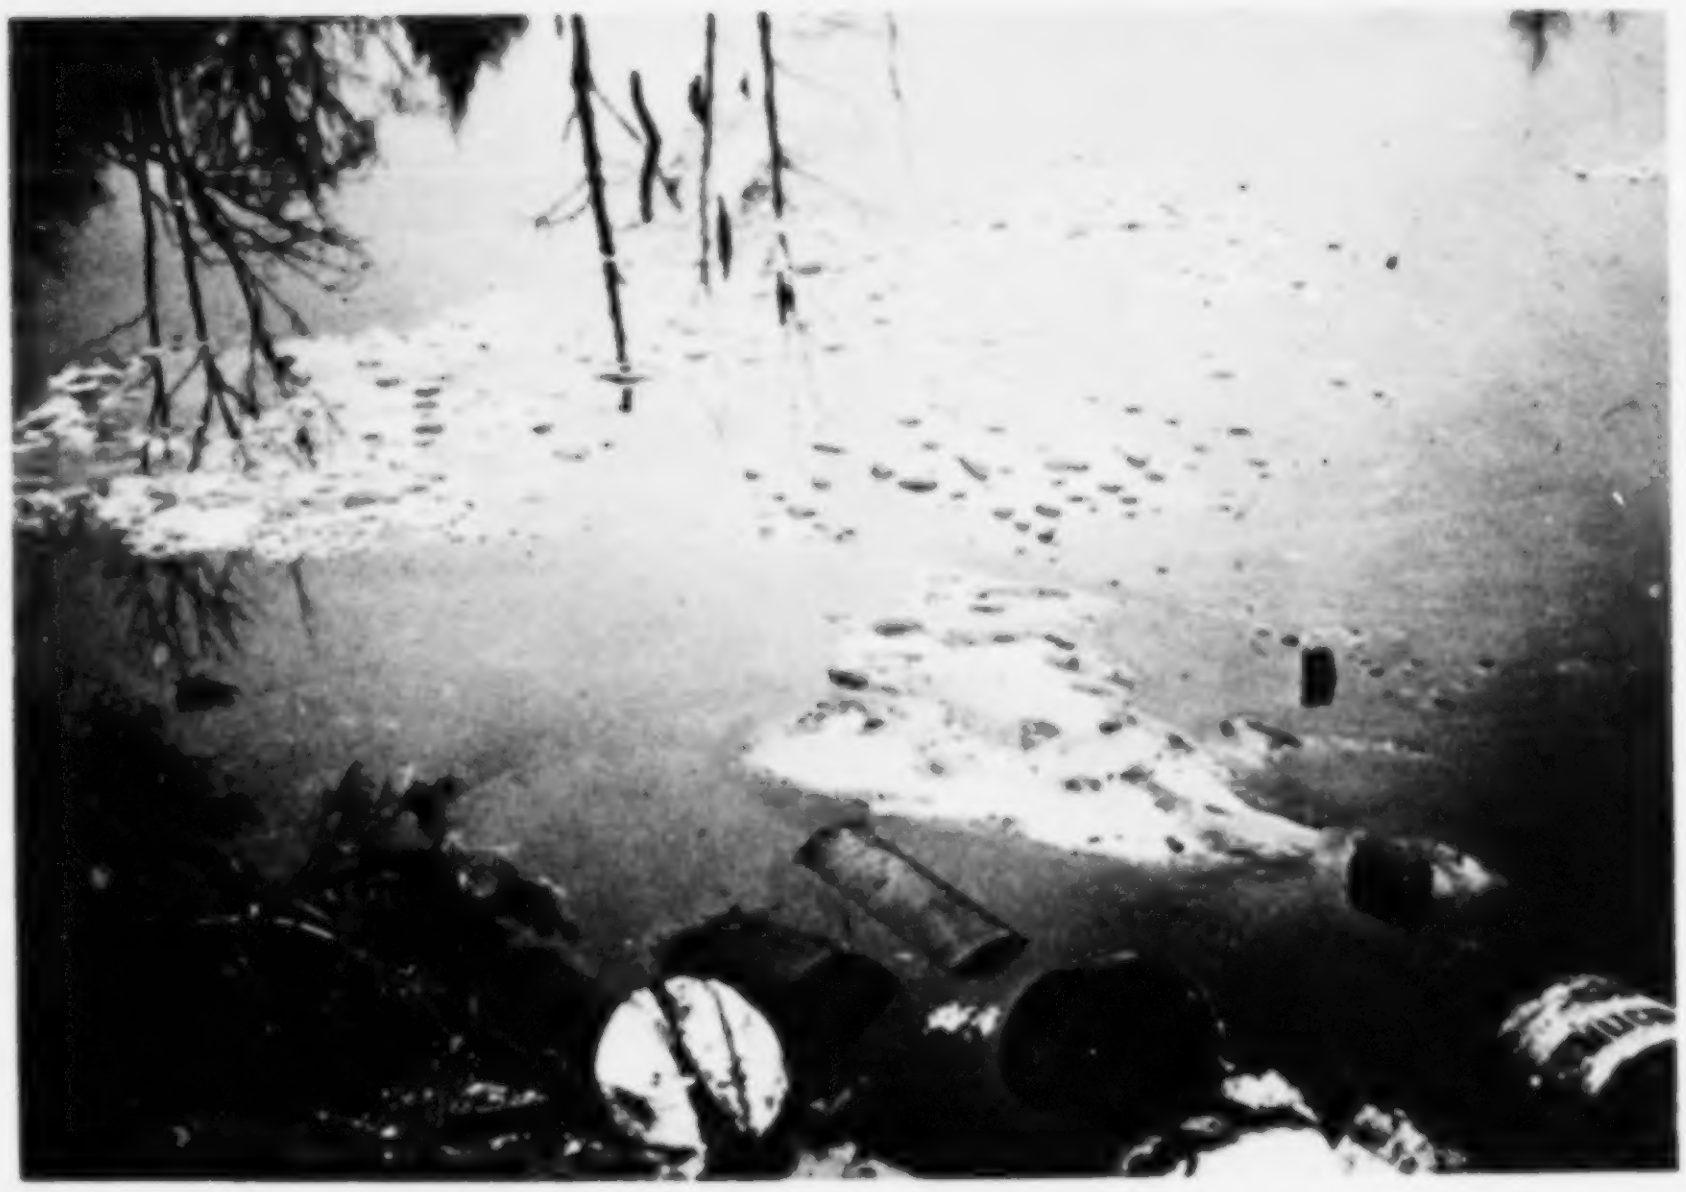
Bank of the lagoon (1966).

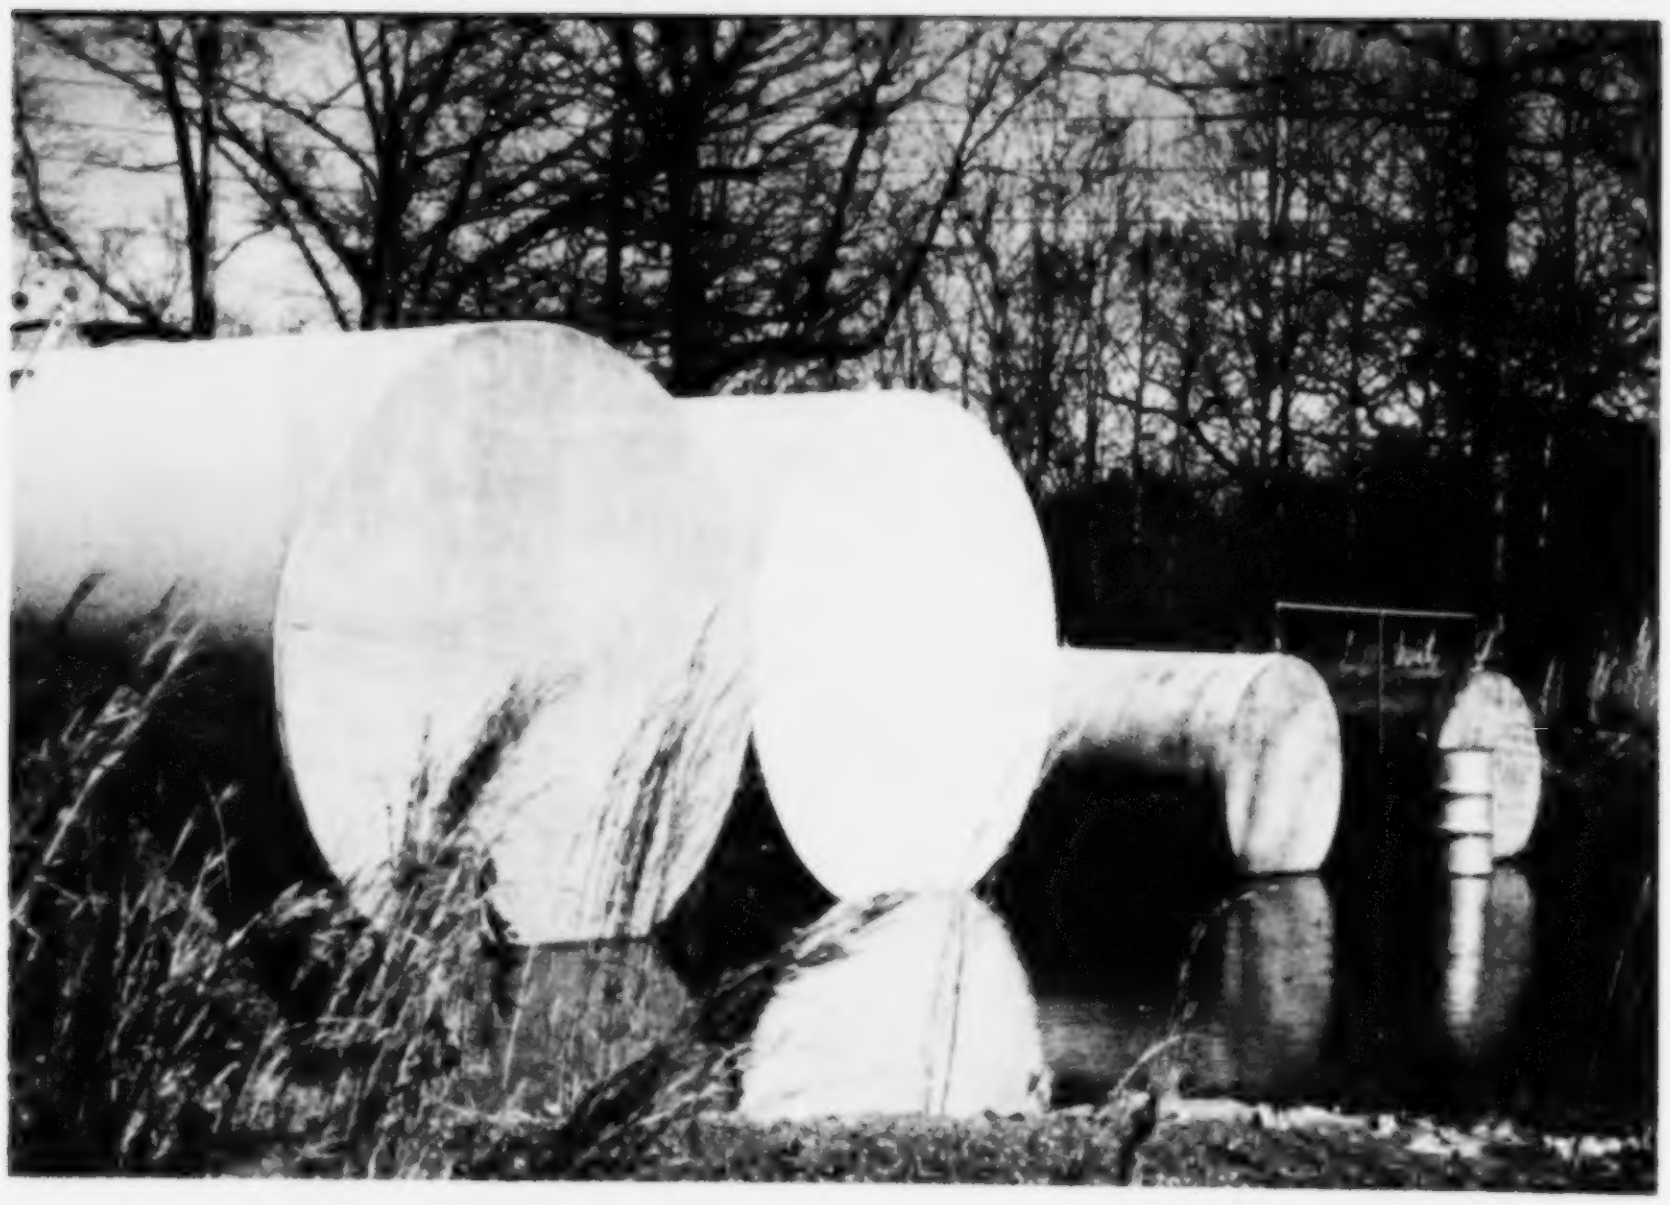
Berms (top photo) were placed around the tanks following the 1977 spill. By March 1980 pools of water had collected in the bermed area around the tanks (bottom photo).

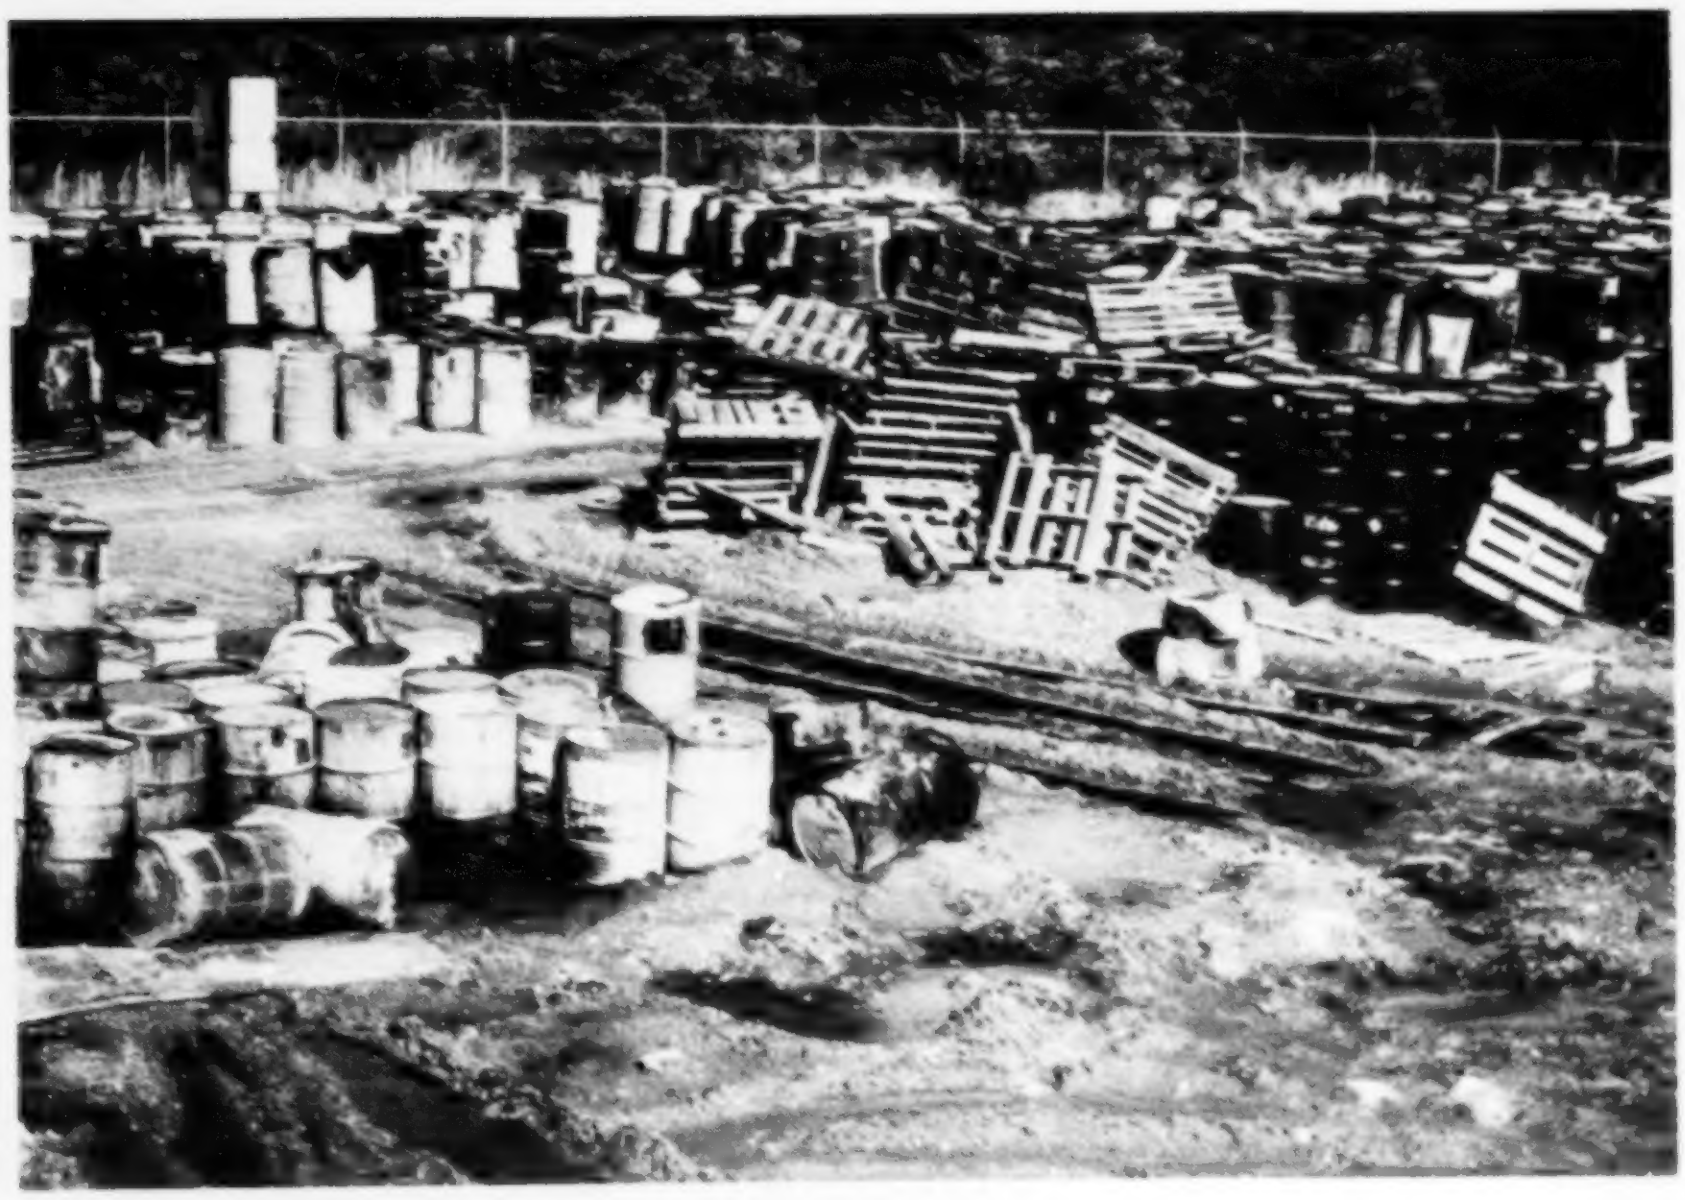
As evidenced by the photo of March 1980, the site was poorly managed by Carolawn, the successors to Destructo.

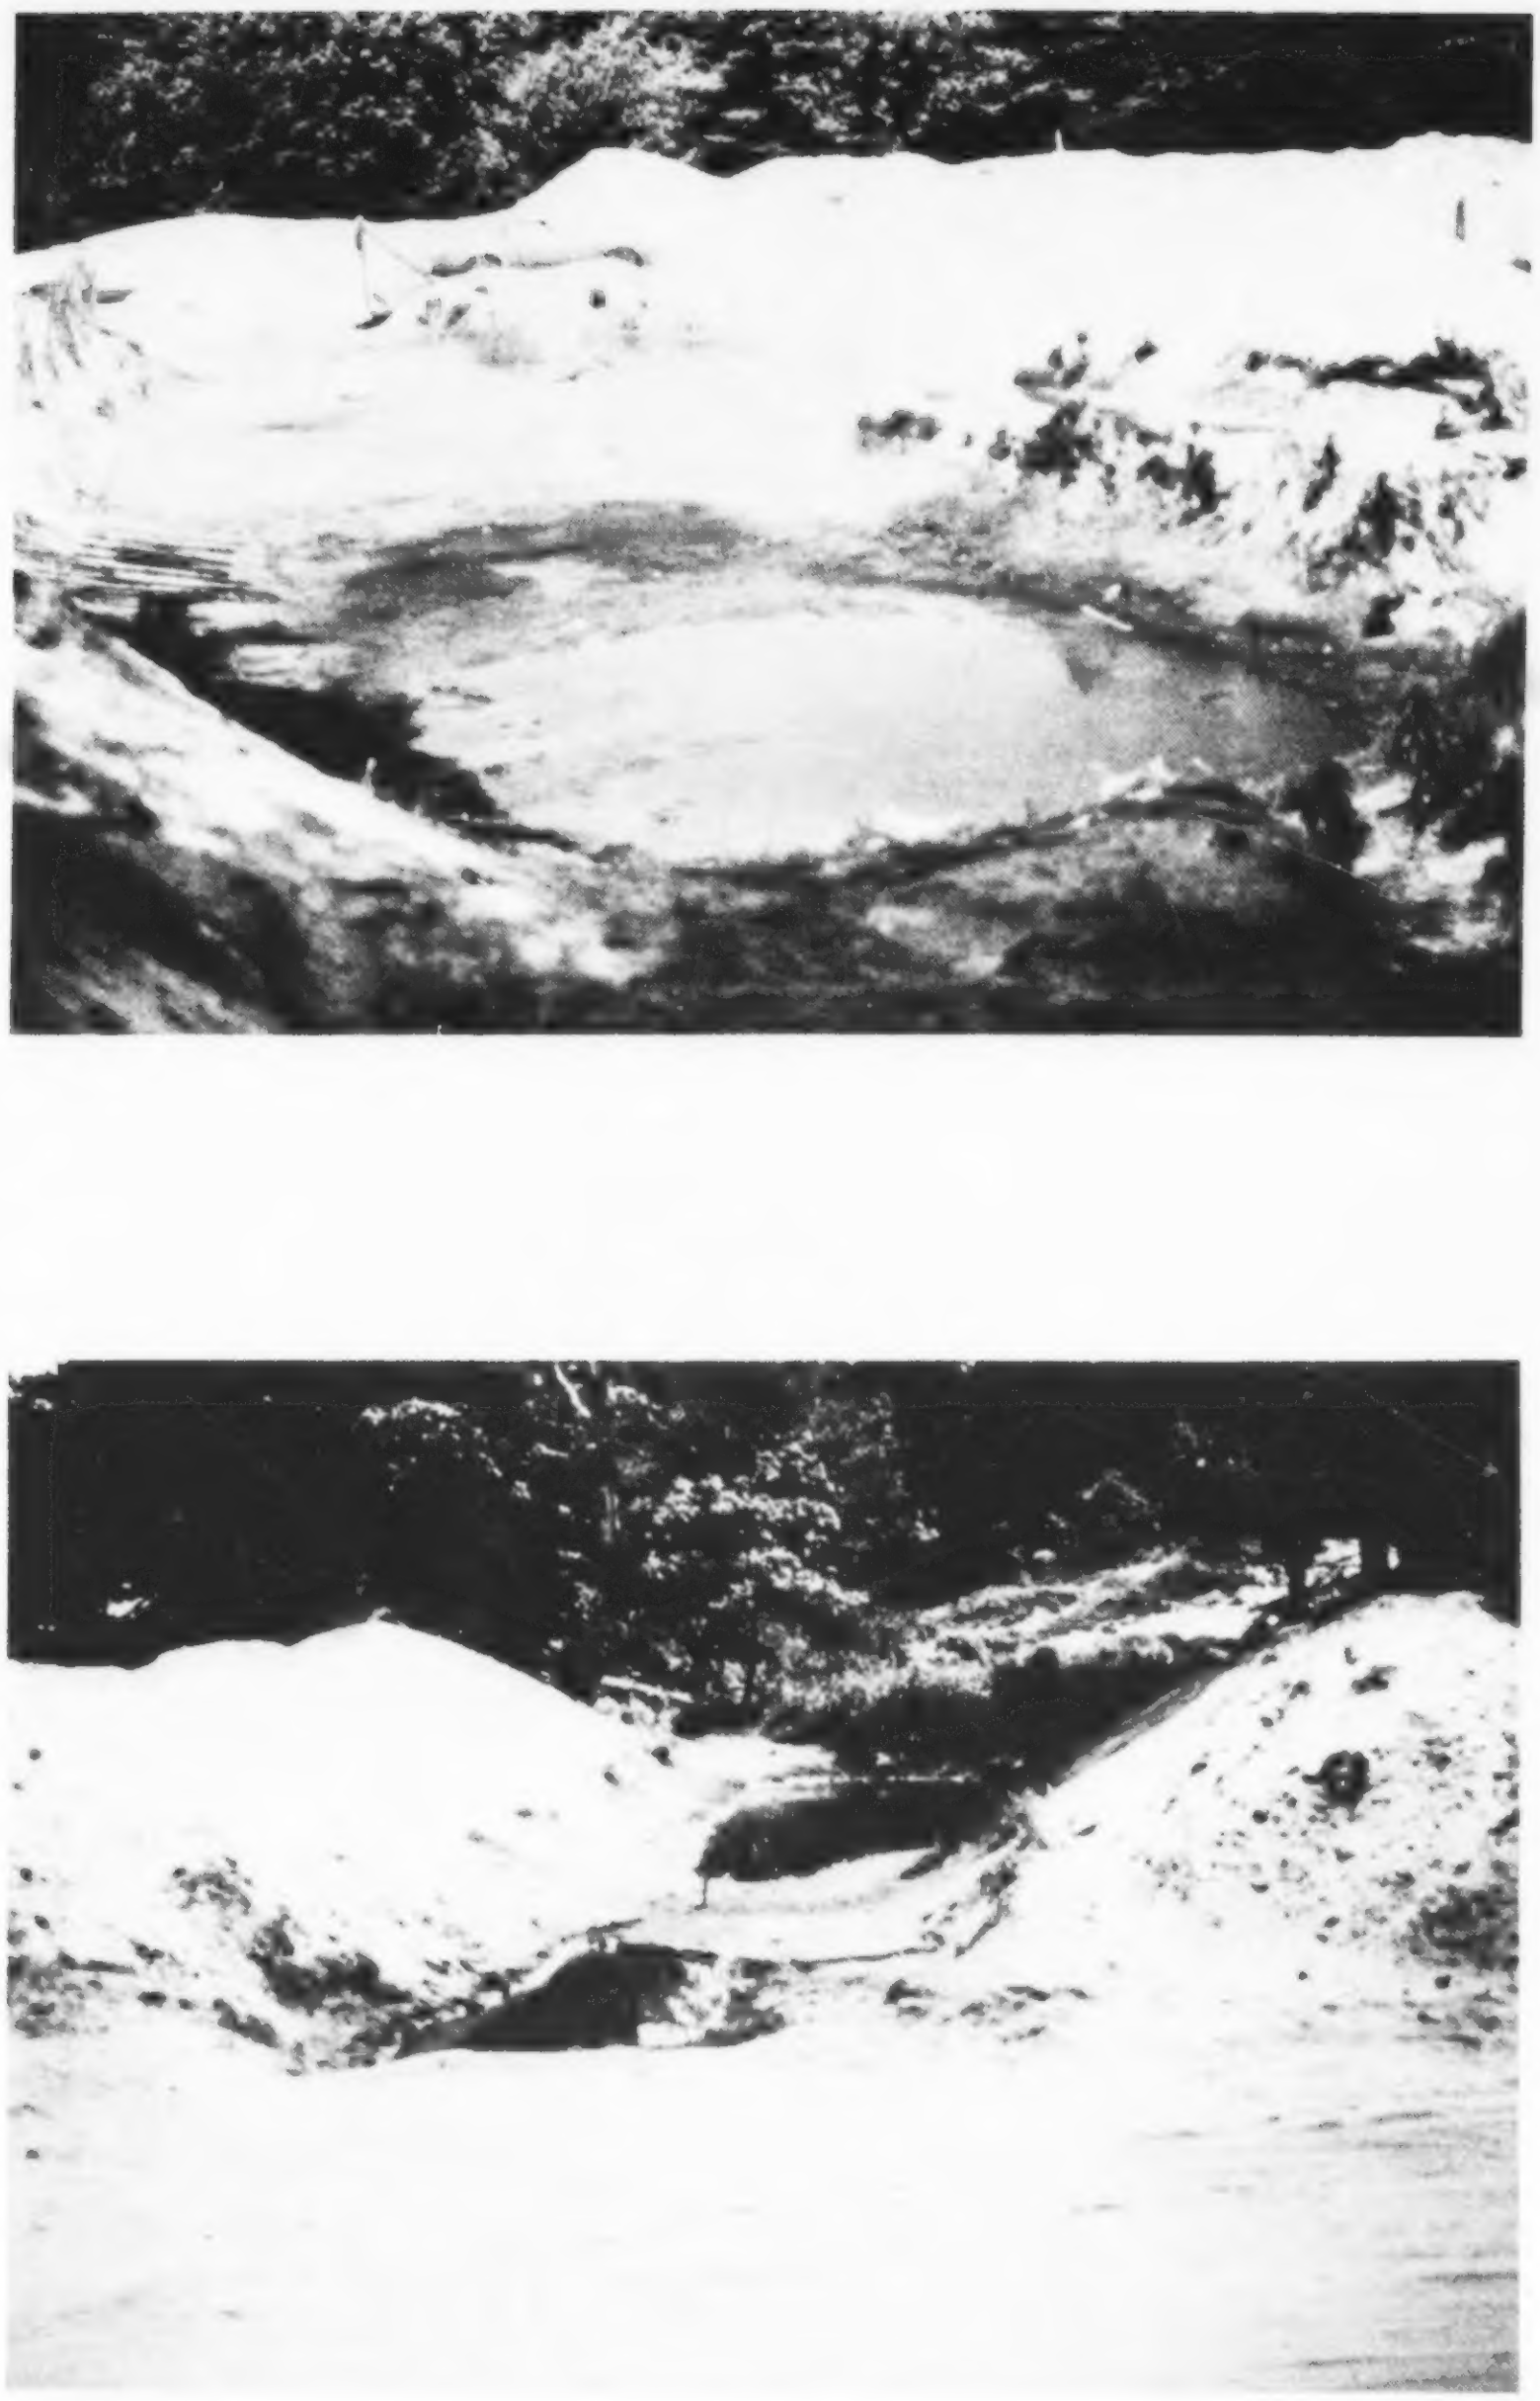
Two waste disposal pits at Western Sand and Gravel. Note the excavated sand characteristic of the disposal site.

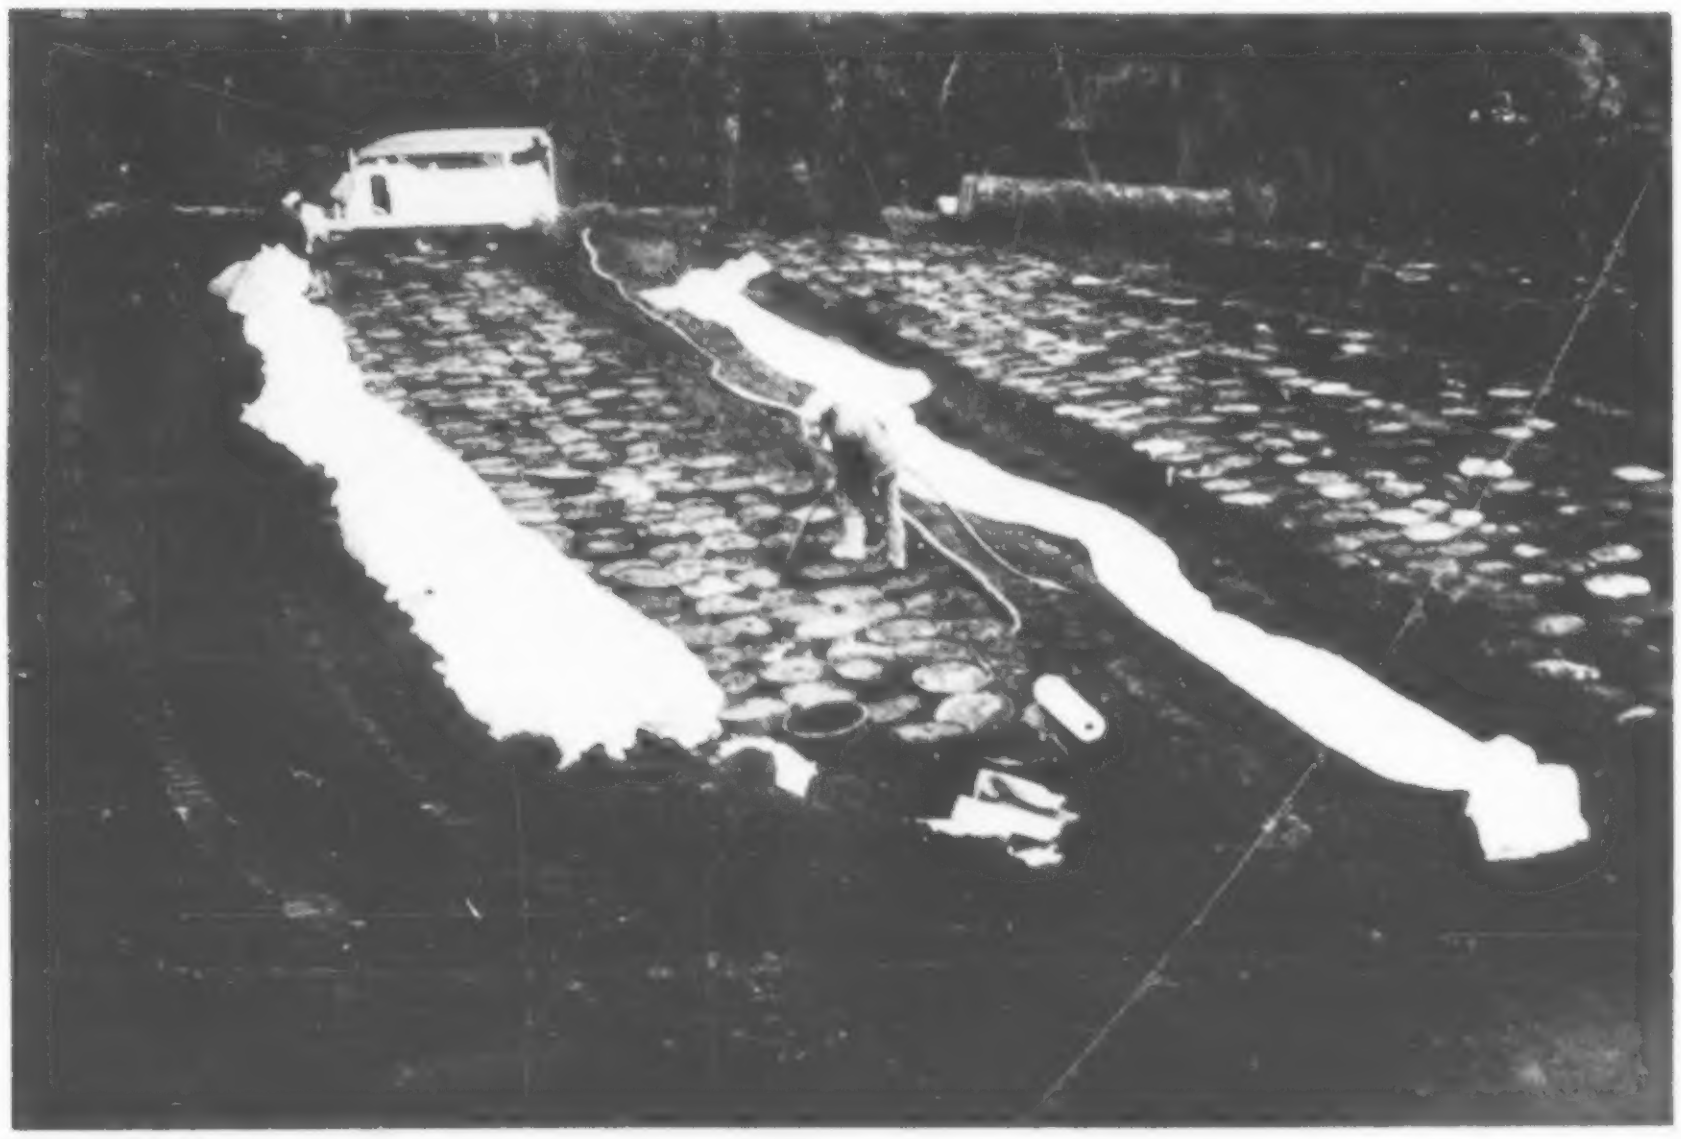
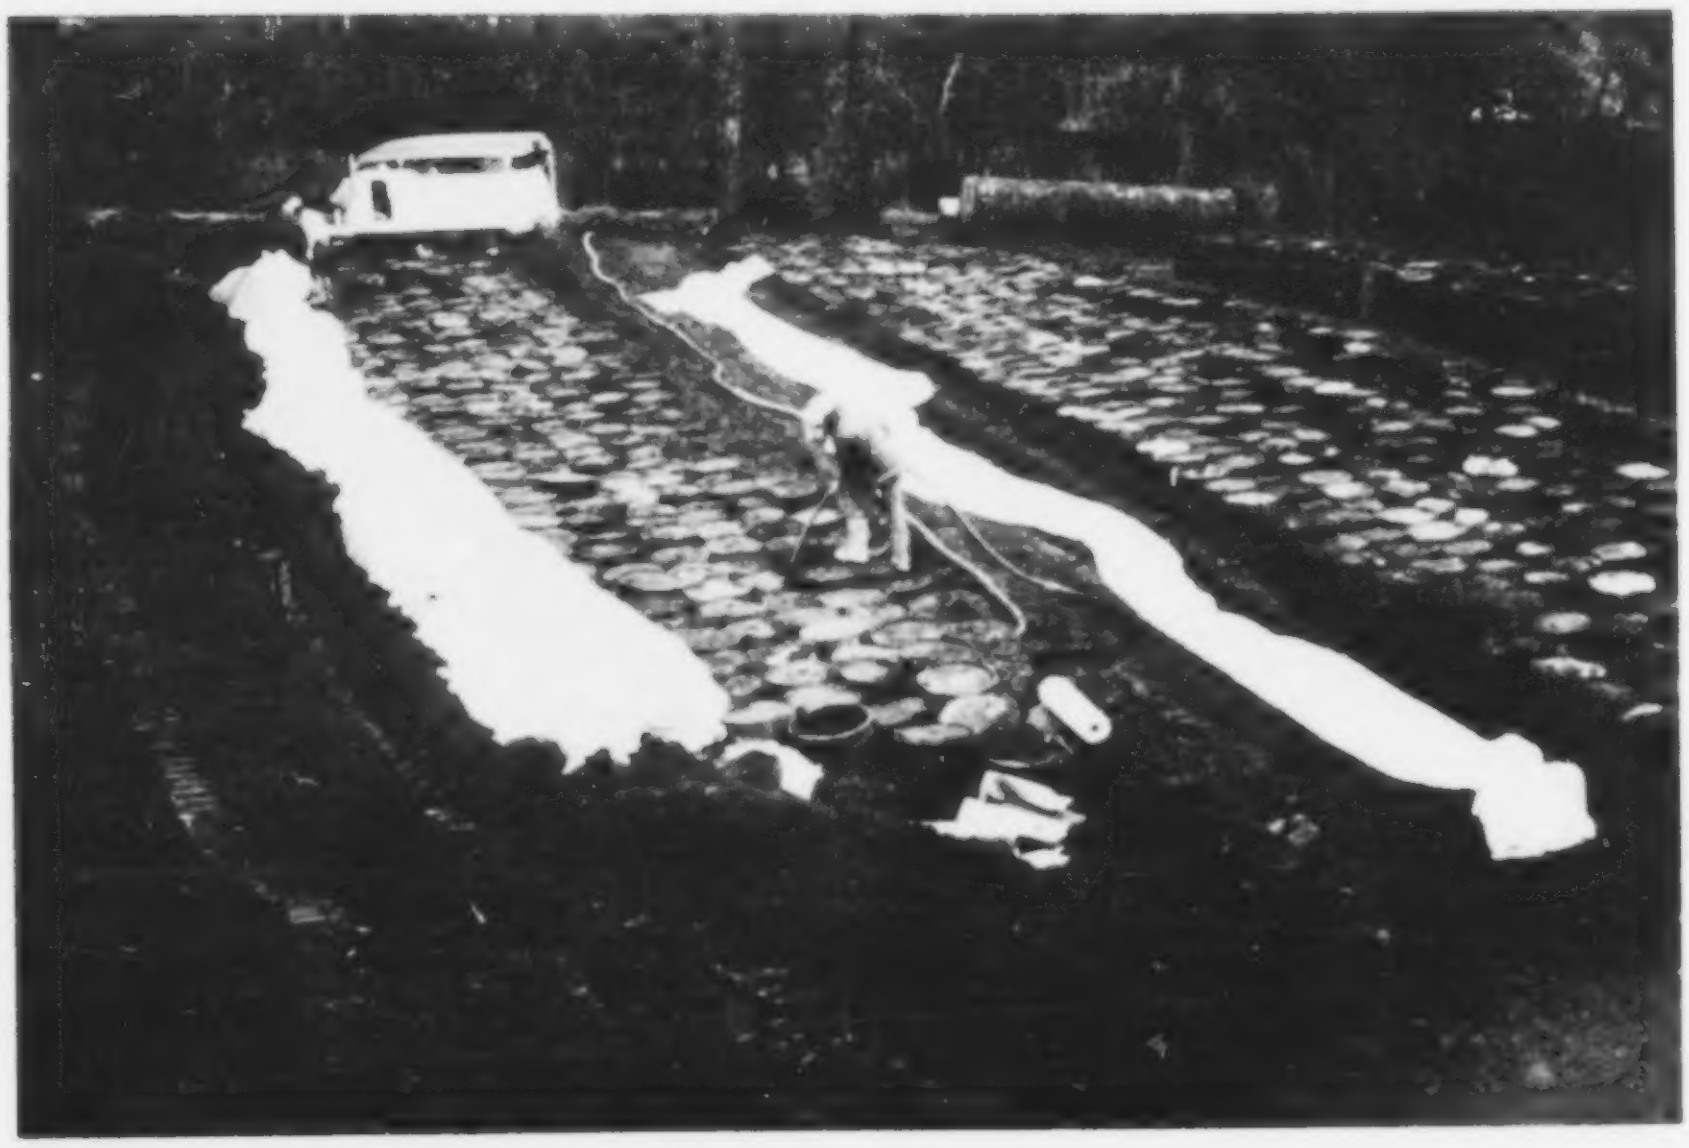
During the first applied remedial action the drums were placed in trenches and a plastic liner placed on top prior to soil addition.

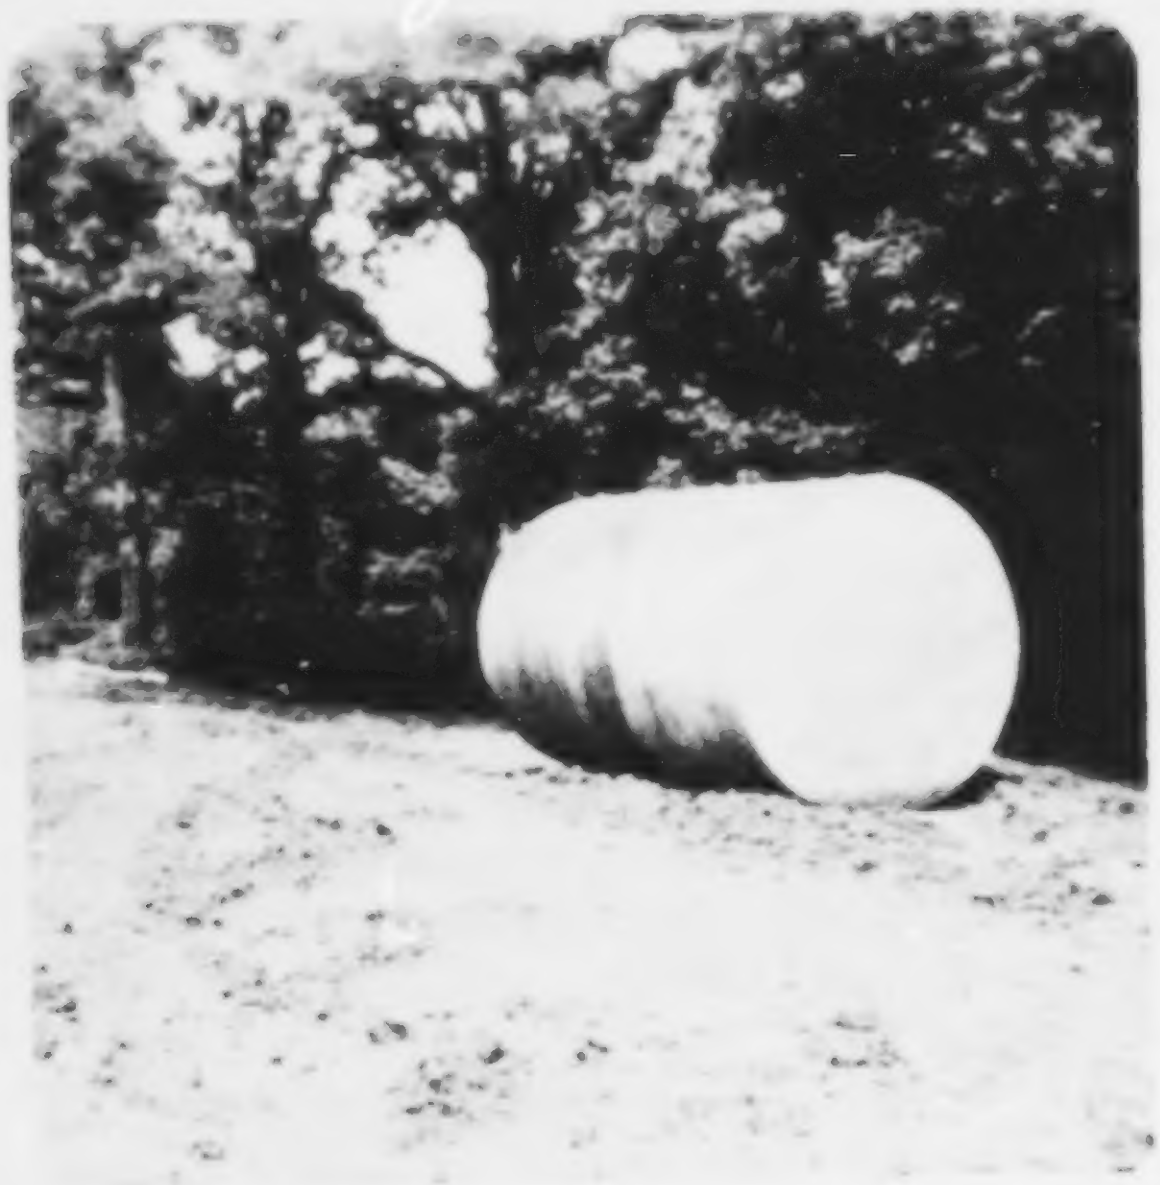
38 m^3 (10,000 gal) barrel containing solvent sludge remaining at site pending further cleanup.
